Pentium[®] II Xeon[™] Processor Specification Update

Release Date: October 1999

Order Number: 243776-016

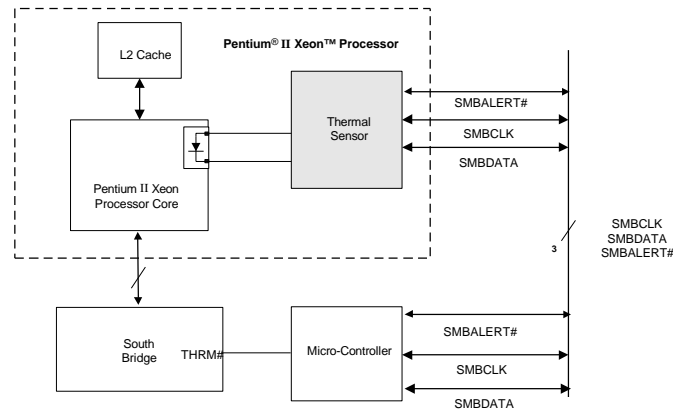
Figure 1. An Example of Microcontroller Driven Thermal Management

D30. Thermal Sensor May Assert SMBALERT# Incorrectly

Problem: The Pentium II Xeon processor has a thermal sensor that monitors the processor core's temperature. The thermal sensor asserts SMBALERT# if the processor temperature exceeds the temperature limits set in the Alarm Threshold Registers (T_{HIGH} , T_{LOW}). It also sets the corresponding Status Register bits to identify the cause of the interrupt. Figure 1 gives one example of the how the SMBALERT# signal could be used in a system.

Under the conditions described below, the thermal sensor incorrectly generates the SMBALERT# interrupt. All of the following conditions must be met to trigger a false interrupt:

Workaround: Three different (mutually exclusive) workarounds are possible:

1. Before servicing an interrupt from the thermal sensor, read and compare the processor thermal reading with the threshold limits (T_{HIGH} or T_{LOW}). Figures 2 and 3 provide basic flowcharts for the implementation of this workaround in an interrupt driven system.
2. If the firmware implemented polls the Status Register only, then before taking any action, re-read the temperature register and do a comparison with the alarm threshold limits (T_{HIGH} or T_{LOW}) to determine if the value is actually still within the temperature window.
3. Use a temperature polling scheme to monitor the processor temperature.
